**GLEN BROOK NO. 4 DAM**

Number  
NDI NO. PA-00650  
DER NO. 19-8

**COLUMBIA COUNTY, PENNSYLVANIA.**

**PHASE I INSPECTION REPORT**

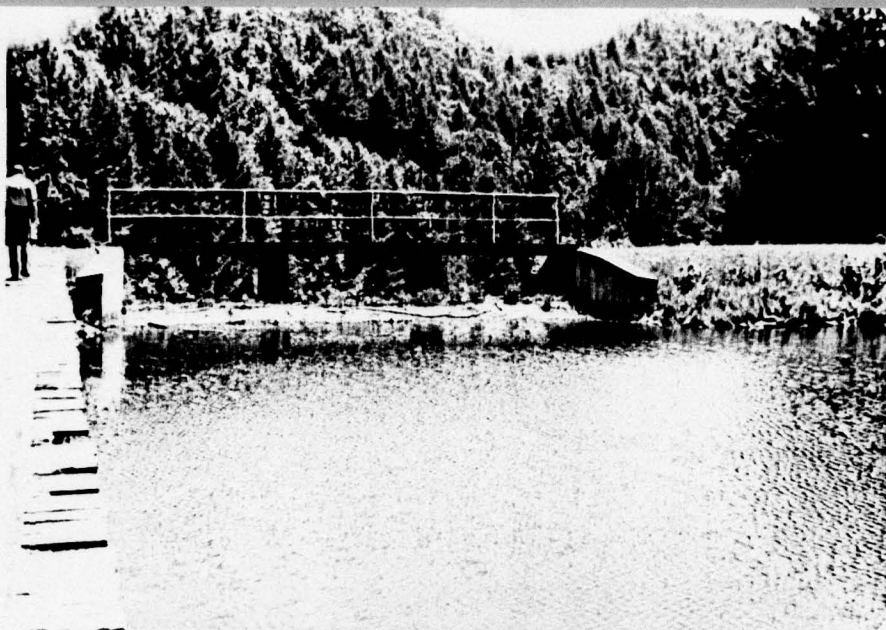
Upstream Slope  
& Footbridge  
Across Spillway

4. That the bridge decks across the spillway and to the intake tower be repaired and that a handrail be placed on the bridge to the tower.
5. That the source of seepage from the weepholes on the spillway chute slab be identified and that the cavity beneath the chute slab at the location of the lowest weephole be investigated and repaired.

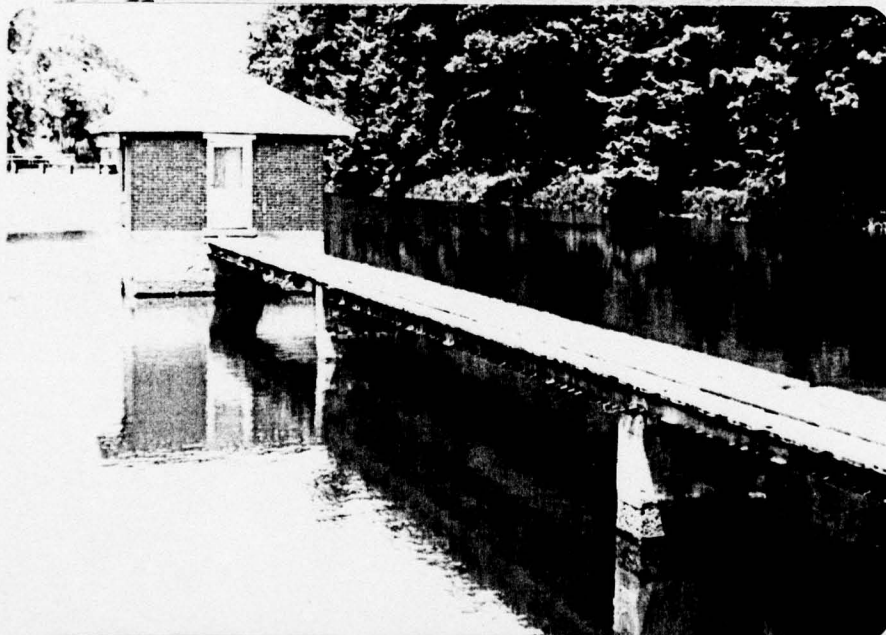
Access to the intake structure is by means of a wooden footbridge on steel beams. This bridge has no handrail and is in fair condition. The deck needs improvement.

The intake structure appears to be stable. The steel beam wooden deck footbridge is usable but it does not have a handrail. Installation of a handrail for safety purposes should be considered. Repairs to the wooden deck should be included in the regular maintenance program.

Footbridge to  
Intake Structure

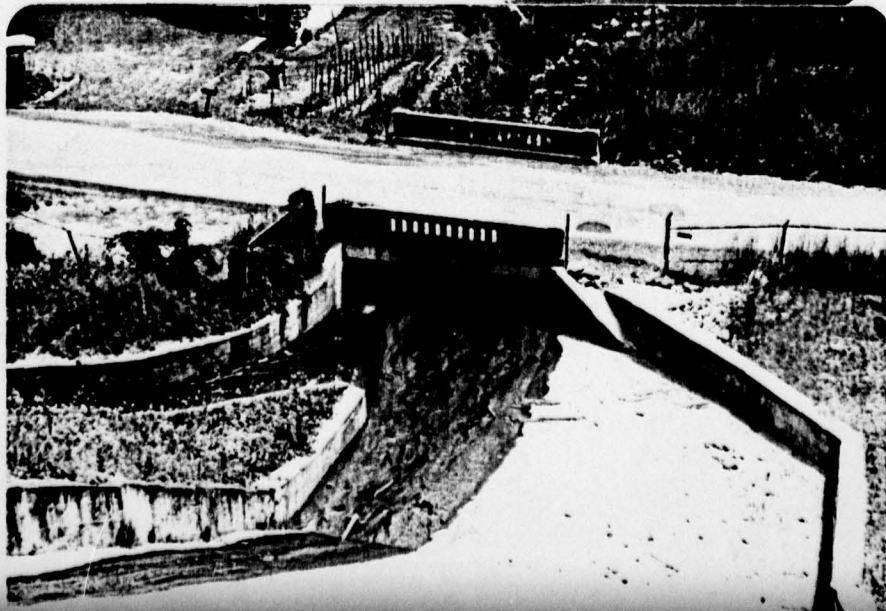
The spillway chute continues nearly horizontally to its termination beneath a roadway bridge. Refer to Appendix F, Plate No. III for plan view. The end of the slab shows some undermining but is not observed to be critical as the slab is sufficiently thick at this location. The drawdown or blowoff pipe discharges to the stream under the roadway bridge.

Downstream Spillway  
Discharge Chute  
& Highway Bridge

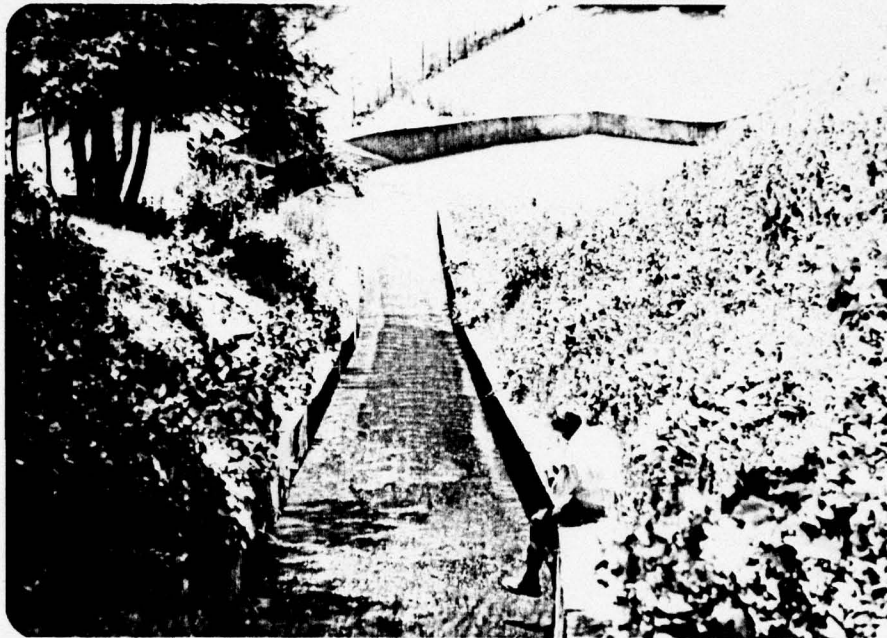
The right wall of the outlet channel from the flume mentioned above forms the left abutment for the earth embankment. The wall of this channel also show some slight tilting. Repairs to the surface of these walls is in evidence. Except for the slight misalignment between wall sections, there is no evidence of instability.

Bypass Conduit Discharge Channel

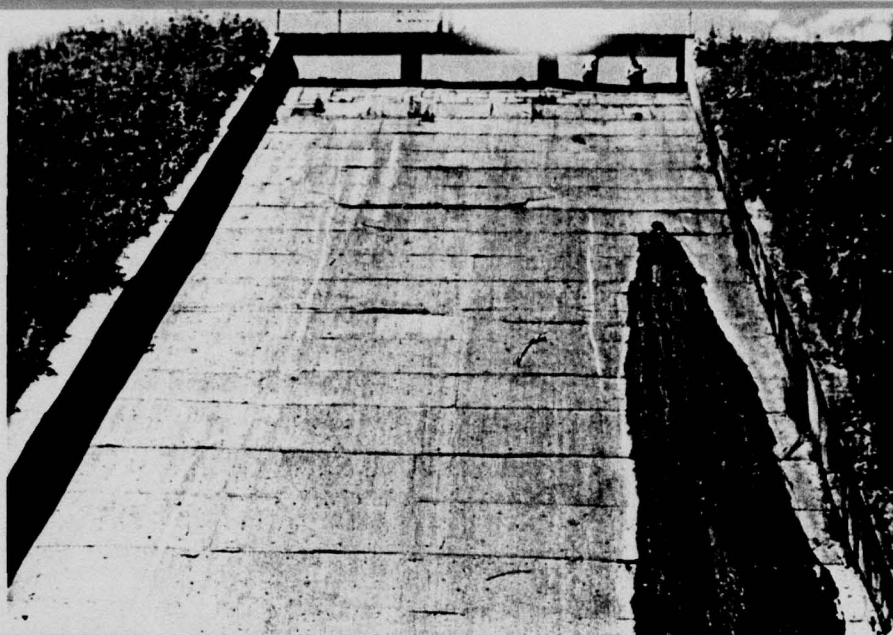
be in reasonably good condition. The spillway chute, at a 1.5H to 1V slope ratio, is bounded by concrete walls. The wall sections are tilted slightly inward creating small projections into the channel between sections. This does not appear to be a serious condition, but it should be closely observed on a regular basis for possible progressive movement in the future.

The spillway chute slab contains four six-inch diameter weep-holes located about 10 feet from the left wall and at vertical distances of about 13 feet between holes. The lowest hole is approximately 18-inches from the bottom of the chute slope. Three of the holes were discharging water. The top hole was dry. The estimated flow from the three holes is about 40 to 50 gallons per minute. A section of downspout was inserted into the bottom hole and extends about three feet out from the surface. Close examination of this hole observed that the section of downspout was loose and can easily be removed and that a cavity exists beneath the slab. The discharge was clear.

Spillway Discharge  
Chute

3. That maintenance of the flagstone forming the spillway crest be continued to provide a smooth entrance into the spillway chute and that the slight projections on the spillway chute walls be smoothed for better flow characteristics and to minimize further aggravation of the condition.

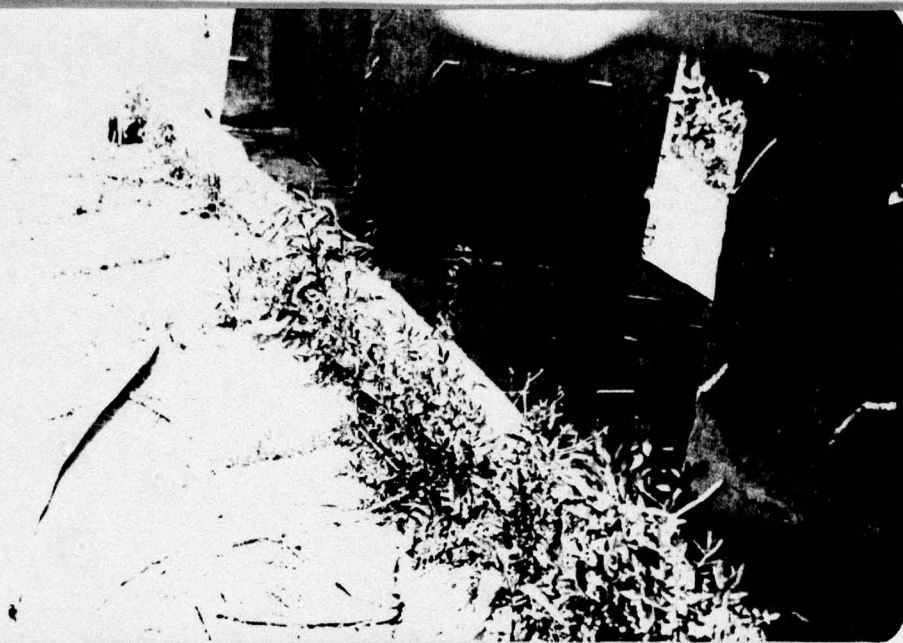
The uncontrolled spillway is considered to be in fair condition. The flagstone paving on the crest is reasonably maintained and is sealed with mortar at the joints. The behavior of these slabs under flood or extremely heavy flow is unknown. The outlet channel drops at a rate of 1.5±H to 1V to a nearly horizontal slab at the bottom near the elevation of the natural stream channel. The training wall sections of this channel show evidence of some tilting inward toward the channel. The tilting is not severe, but some slight projections between the sections exist. These projections could possibly aggravate the condition during high flow through the channel. Providing a fillet to create a smoothed surface across the projections would improve the condition. Evidence of other surface repair was observed along the walls on both sides of the channel. The bottom slab and walls below the sloped section appear to be stable and in good condition.

Flagstone Spillway  
Weir and Footbridge  
Piers

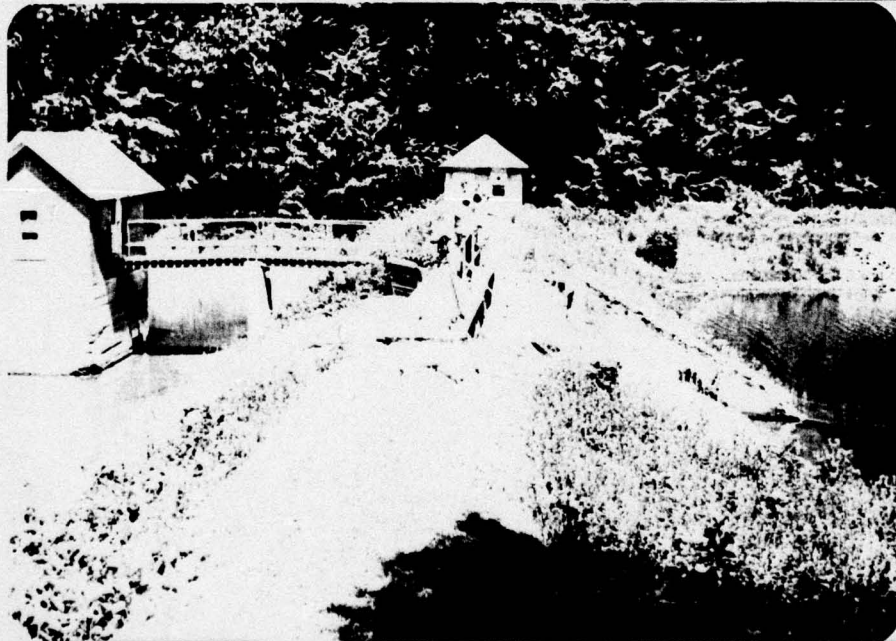
The spillway is severely deteriorated with displaced flagstone slabs, cracked side walls and general deterioration.

The Upstream  
Glen Brook  
No. 2 Dam

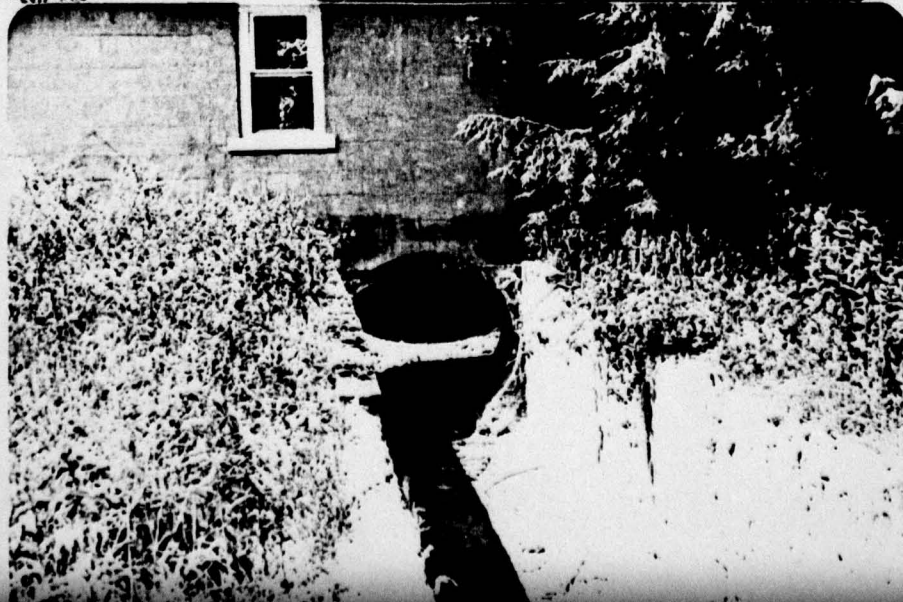
No.2 Dam Reservoir is small. The owners observed this dam closely during heavy storms to prevent water from passing over the main spillway. This is accomplished by opening the 20-inch blowoff pipe and the wooden butterfly gate. The structure, housing the wooden gate is in very poor condition inside.

Bypass Conduit  
Gate at No. 2 Dam
